# International Sealing Conference

# **Influence of surface quality of different nitride treated piston rods on the sealing behaviour of hydraulic piston rod seals**

**Dipl. Ing. Thomas Papatheodorou, Dipl. Ing. Walter Igers**

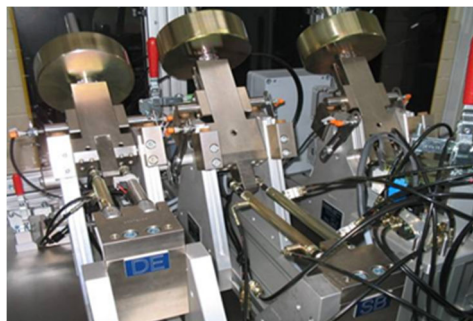
*Figure 3: seal testing in convertible roof applications*

The ISO hydraulic endurance seal tester consists of 6 test chambers where 2 seals or 2 complete sealing systems can be tested in each test chamber (figure 2). In addition, specific customer test set-ups were used to examine the seals under customer specific test requirements. Figure 3 shows the test set-up for seal testing in convertible roof applications and figures 4 and 5 show the test set-up for seals in gas spring applications. Figure 4 shows the set-up for testing of original gas springs while

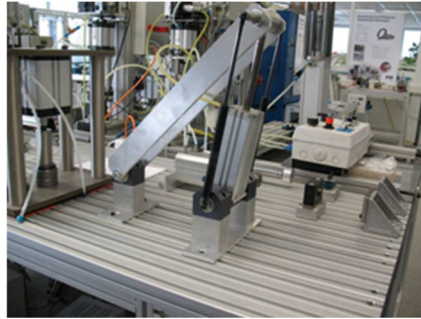
*Figure 4: seal testing for gas spring applications*
